Pre-Drywall Property Inspection

Date: 8/11/09
Weather: Overcast
Time: 1:00 PM
Buyers: Joe & Andi [REDACTED]
Property Address: [REDACTED] Powder Horn
City: McKinney, 75070
Realty Company: ReMax
Associate: Steve [REDACTED]

The house is a single story.
The building contractor is David Weekly.
This inspection took place prior to drywall installation. Water was on at time of inspection.

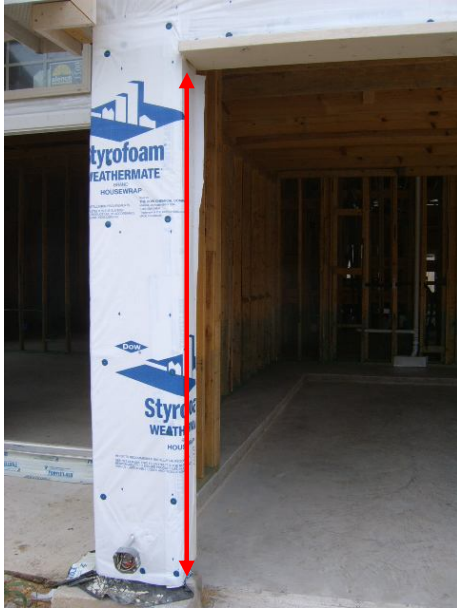
1. small door - the east jamb is out of plumb by 3/4 inch
2. larger door – need to work out the issue regarding the protruding concrete curb and the attachment of the final door jamb

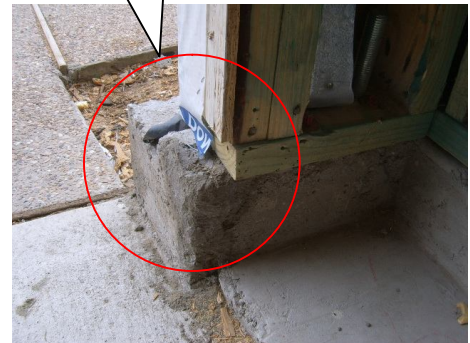
Something will have to be altered so that the jamb sides will fit at left and right jamb leg of the larger garage door opening.

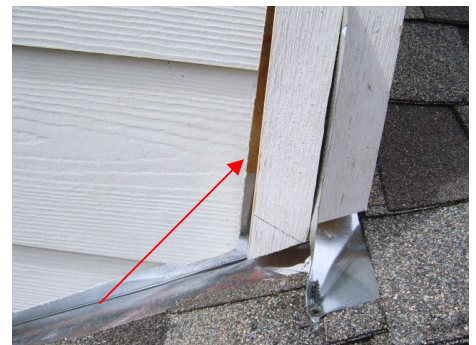
1. Chimney – can see the framing beneath the offset siding. Missing 15 pound felt or waterproof membrane beneath the chimney siding to seal out any moisture that may bypass the siding. Same is true of the roof dormer at front of home

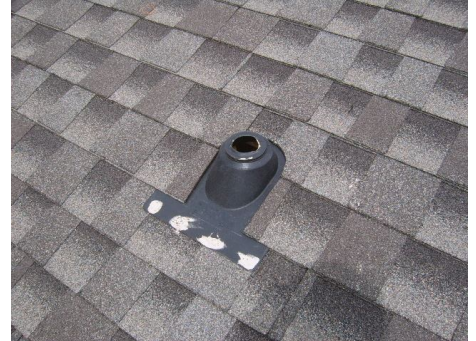
1. Water heater flue penetration collar needs to be sealed.
2. One plumbing jack flashing at the south elevation is not being used, remove and patch roof.

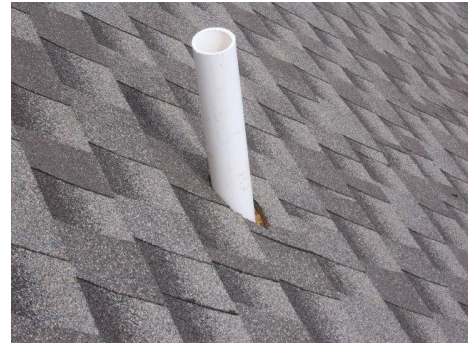
One plumbing vent pipe is missing the jack flashing at the east elevation above the master.
