PROPERTY INSPECTION REPORT

Concerning: Willow Grove, Dallas, 75229
(Address or Other Identification of Inspected Property)

By: Robert Taylor 3619 5/1/08
(Name and License Number of Inspector) (Date)

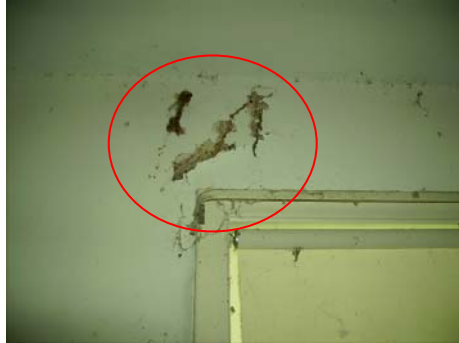
1 Termite evidence garage

Termite damage an activity observed at the west wall of garage. Ask seller for any treatment history for wood destroying insects.

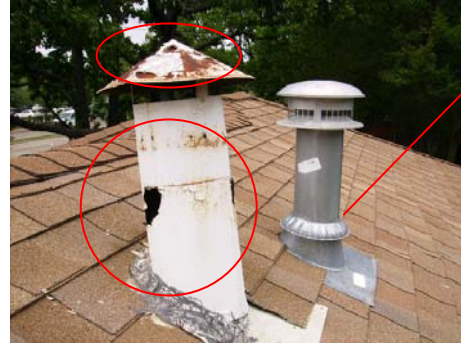
Rain collar
need to seal

2 holes through old furnace flue

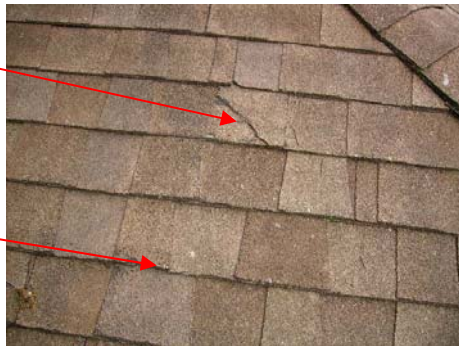
3 areas of roof shingle abrasion

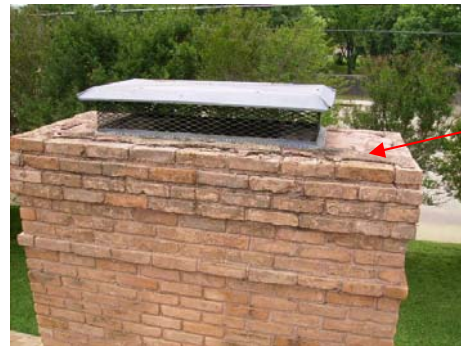
Number of Fireplaces:2. Fire Box: Masonry
Family Room - When using ceramic logs a C-clamp must be added to the damper to prevent it from closing fully. Observed creosote buildup (advise cleaning of chimney flue. I do not have a gas key that fits, unable to turn on the gas valve.
Living Room - Review and seal the metal damper frame to the firebox as needed.
Chimney caps deterioration, loose cement top in need of repair.

4 chimney cap erosion

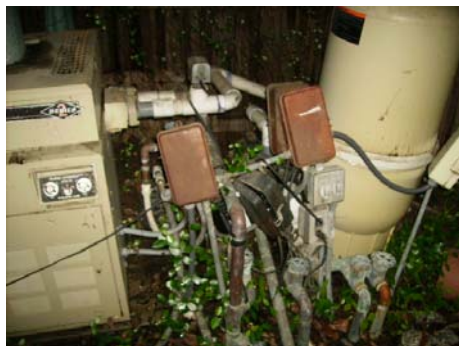
AT THE EQUIPMENT Area: 7] **defective GFCI** associated with the pool light, 8] hazardous wiring landscape time clocks are plugged into the equipment service outlet, freeze guard box unsupported, missing all casing grounds to the heater and motors (REVIEW WITH ELECTRICIAN), 9] epoxy patched plumbing line connections to motors, 10] a motor (I believe intended for the spa) is nonoperational at this time. 11] The pool heater is connected to the inoperable spa pump so it could not be turned on, unable to evaluate the heater operation. 12] wet pool equipment pad may be leak or recent rain?

5 pool equipment - electrical hazard

ADVISE get a complete evaluation for estimate of upgrading and repairs as needed by pool concern company.

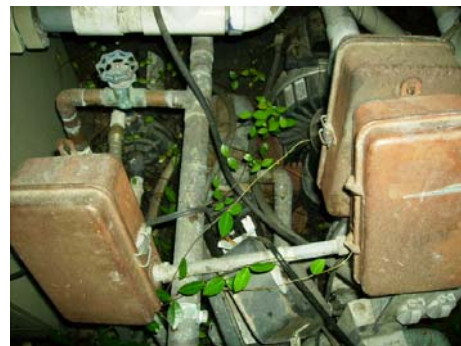
6 spa motor pump out (hard to see)

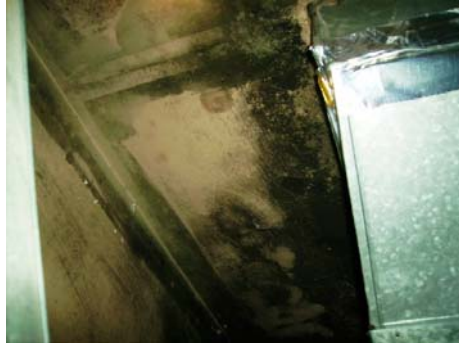
7 Looks like mold at furnace closet

Dark stains appear to be a mold at the furnace closet ceiling.

MOLD - Where mentioned in the report follow up by identifying location of underlying cause, i.e. moisture. Recommend testing by qualified lab & treat as necessary according to results of test.

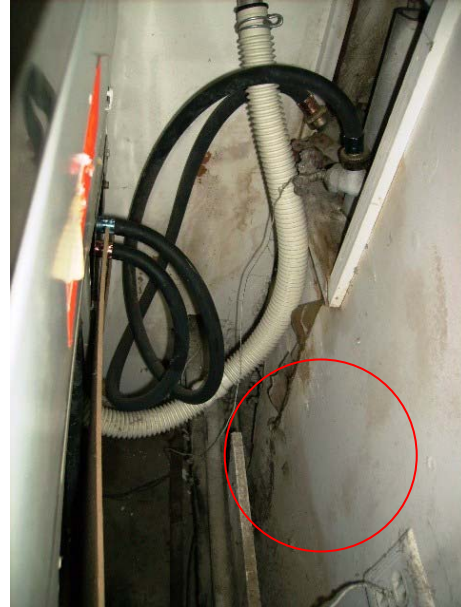
8 mold behind the washer

Wall deterioration and appears to be a mold type behind the laundry washer.

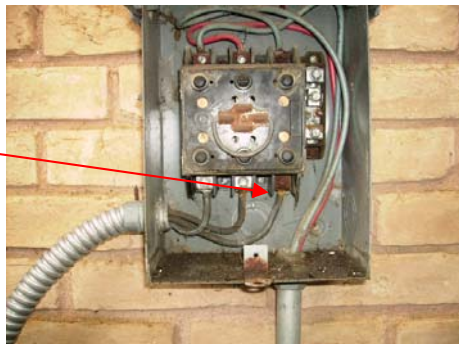
EQUIPMENT DISCONNECT: interior wire shield is in the planter, rust present at the wire connections to the disconnect, review with an electrician.

9 rust at AC disconnect connections

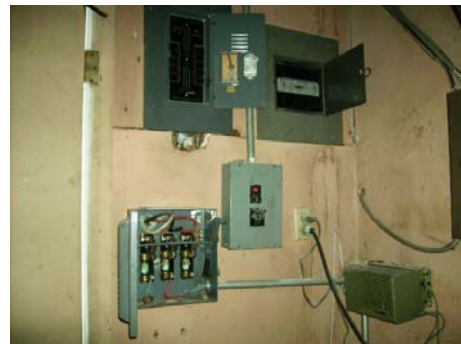
10 Advise review with electrician

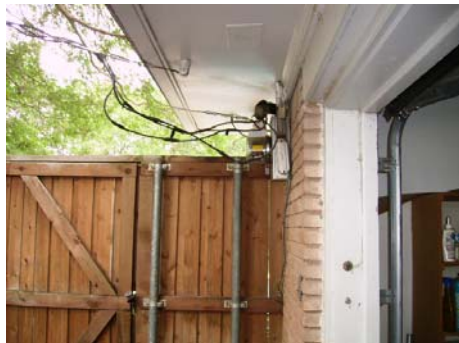
Service Line – connection to building is not to current standards. Danger the service line is easily within reach but should be at least 10 above adjacent grade level.

11 caution - service line in reach

I advise a review of the existing system with a licensed electrician. It is likely the service drop and main panel will need to be upgraded.

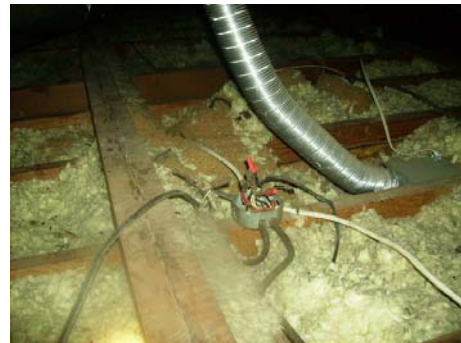
ATTIC: Electrical connections out of junction box observed at least two locations. Junction boxes missing covers I counted 10 but did not access area above family room and garage; an electrician should examine attic for others and correct as well.

12 in the attic at least 10 electrical conditions noted

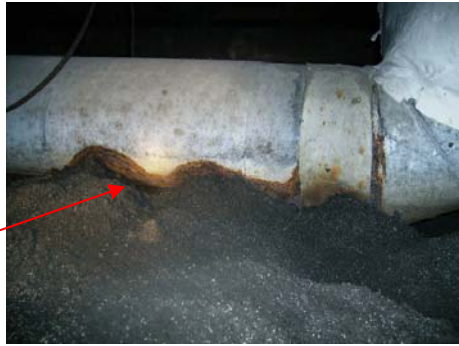
DUCTS: Limited view of ducts in the crawl space due to tight constraints. Metal ducts are in contact with the earth which is causing them to deteriorate, there is little or no room to hang them from the floor joists, some earth will likely need to be removed. Ducts rusting badly in some areas and at least one open visible joint that will draw air in from the attic beneath the dining area.

13 Rusted ductwork contacting earth

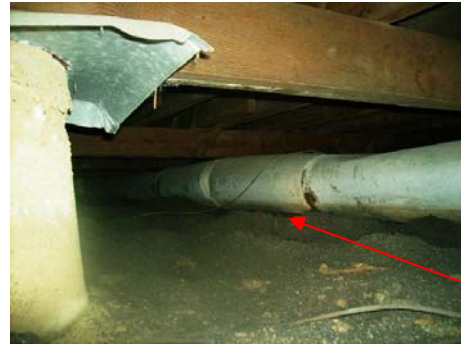
14 many rusting crawl space ducts

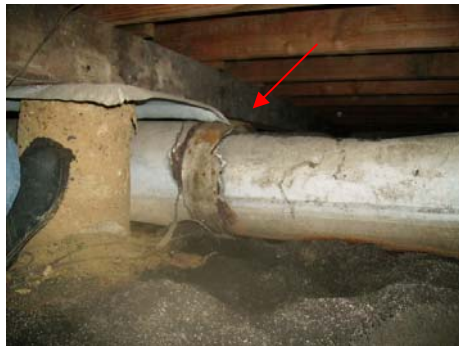
15 drawing air from crawl space

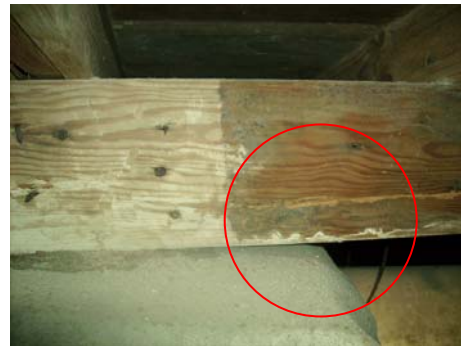
CRAWL SPACE - Wood destroying insect damaged observed at one floor joist with past activity somewhere beneath the entry to living. Take action to reduce high humidity levels in the crawl space correct drainage around home and consider adding a fan to move air through the crawl space. Presently the earth is very moist throughout the underside of the home, mushrooms growing at the south elevation along entry and living room. A light dusting of mold can be seen on wood floor joists and flooring (but not that much).

16 previous wood destroying insect

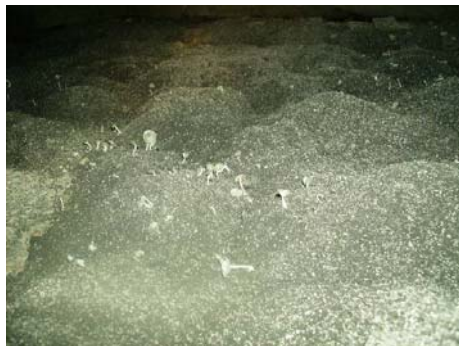
17 damp condition - mushrooms growing in crawl space
