PROPERTY INSPECTION REPORT

Prepared For: Thomas Peff
(Name of Client)

Concerning: XXX Drexel Street #1 & #2, McKinney, TX
(Address or Other Identification of Inspected Property)

By: Robert Taylor 3619
(Name and License Number of Inspector) (Date)

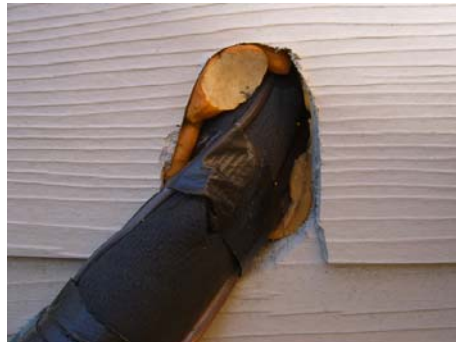
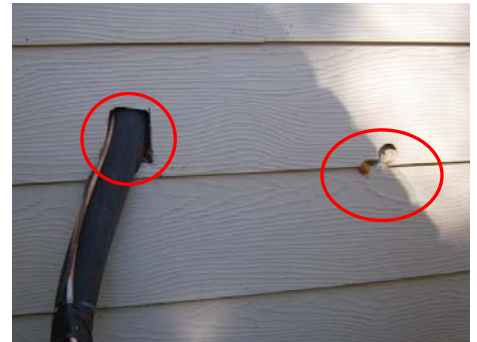
Exterior Advise seal hole where refrigerant lines from compressor coil penetrate the brick veneer.

Also seal a partial drill bit hole.

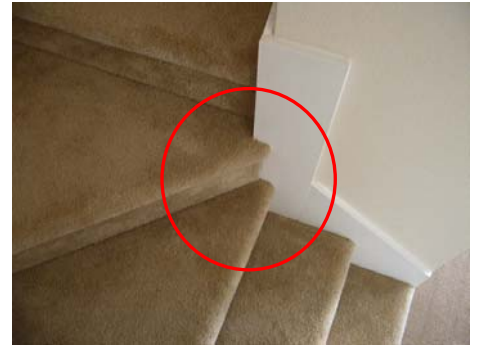
Stairways: Stairs treads on the radius can not be less than 6 inches wide at any point. (current design standard).

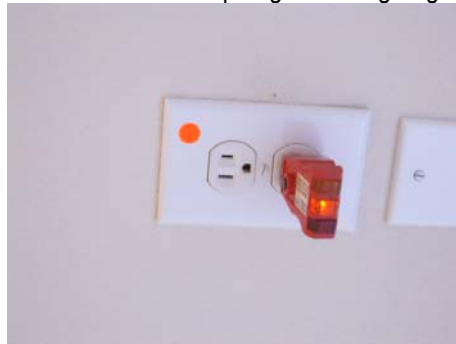
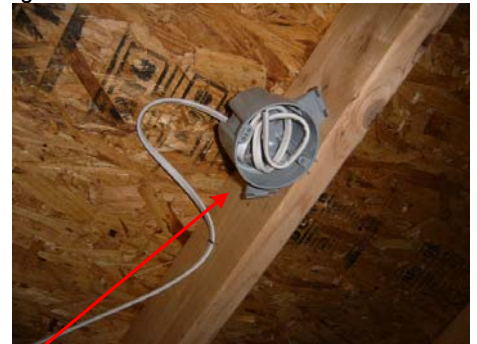
OUTLET: Open ground at garage ceiling.

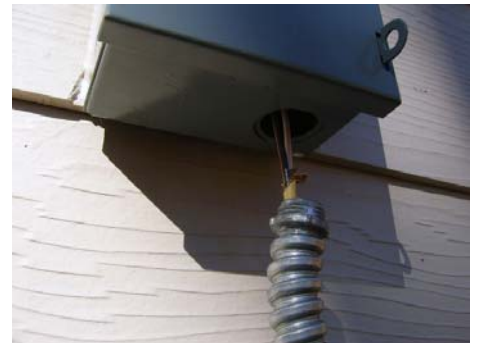
EQUIPMENT DISCONNECT: Loose conduit wires are exposed at exterior disconnect for AC unit.

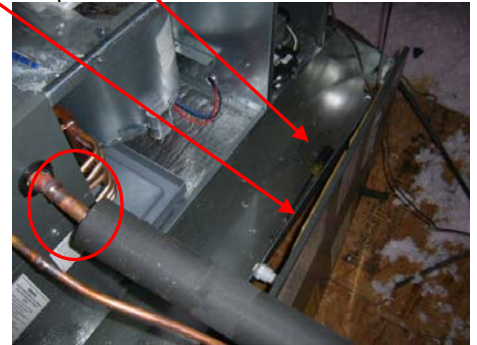
Type Forced Central Air/ Energy Source: Electric/ Manufact: Not Identified
Furnace does not turn on from the thermostat control, review with HVAC concern. Breakers off at panel, disconnect off in attic at HVAC equipment, burner cover is not attached, tools in drain pan.

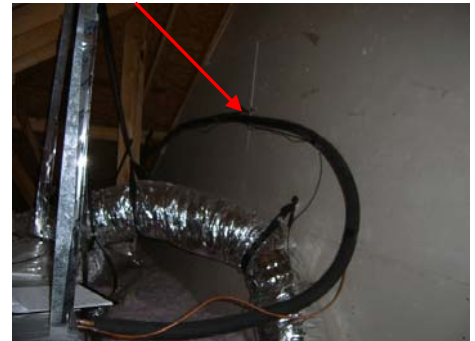
Evaporator Coil: Refrigerant line in attic needs to be supported every six feet. The wall strap is not supporting the line.

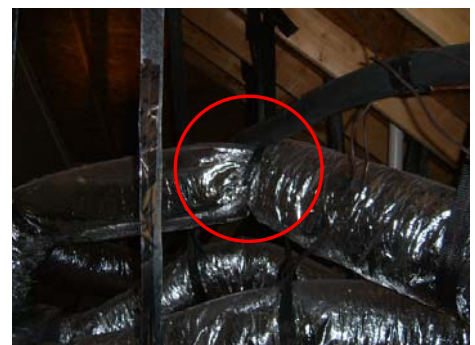
Ductwork pinched where evaporator refrigerant line rests on top of duct.

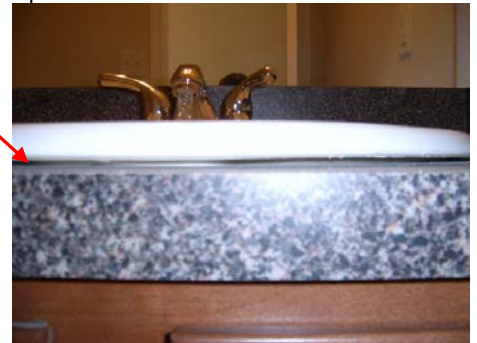
Bathroom Master -
Sink - secure and seal sink to countertop.

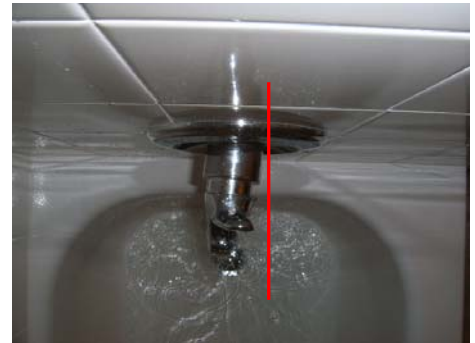
Tub – spout and mixer valve mounting are crooked and do not make a good seal.

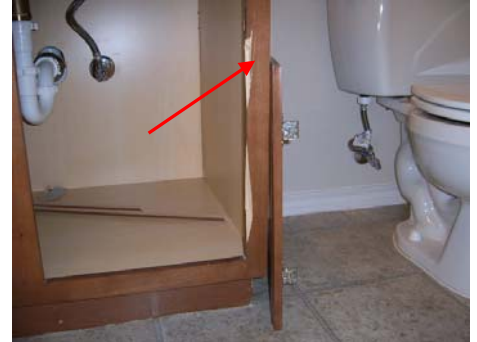
Broken cabinet door attachment at the master bath.
